THE NAVAJO NATION
Division of Natural Resources
Navajo Abandoned Mine Lands Reclamation Program (NAMLRP)

Scope of Work for the NAMLRP Projects:

Cameron 6 AML Project - NA0175; alternative 1

NA-CITS DIKE REPAIR

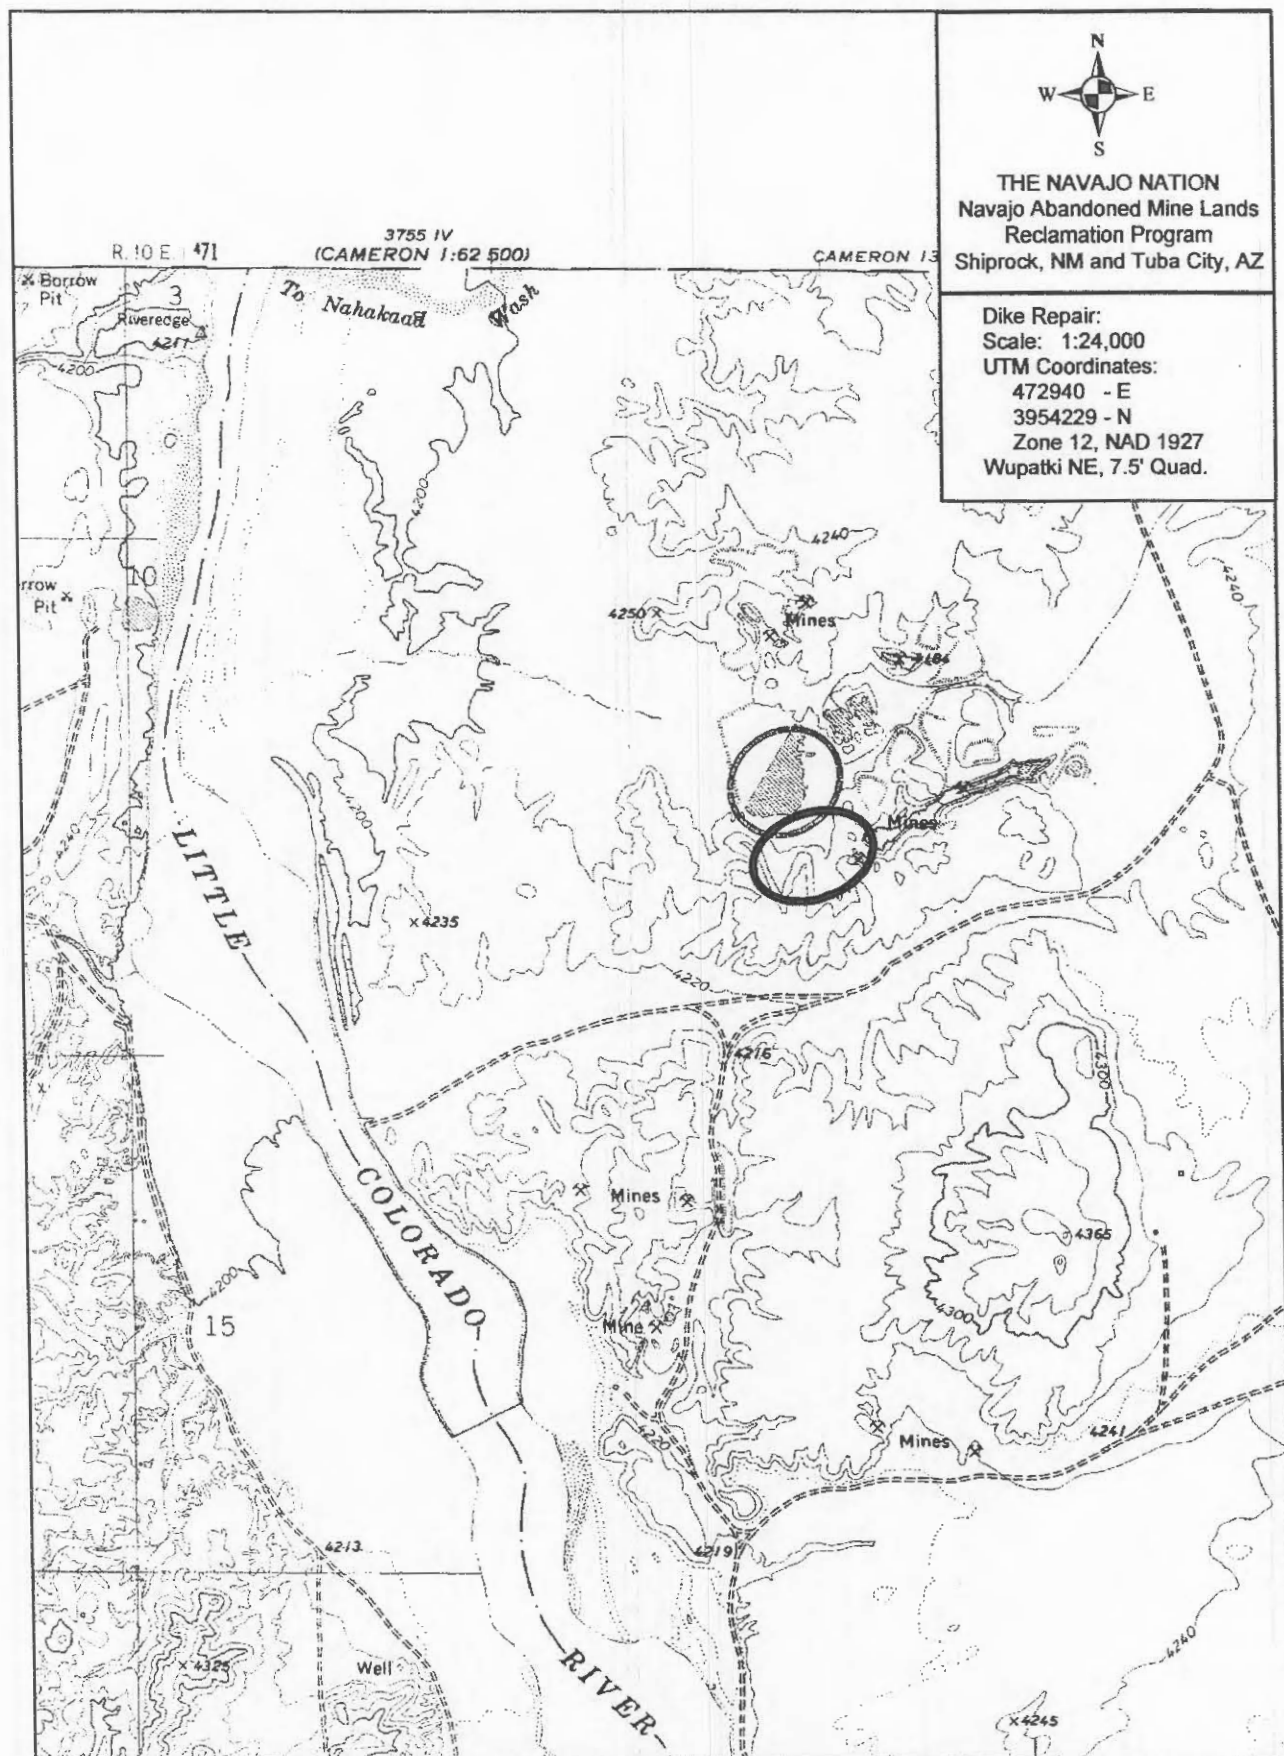
Cameron 6 AML Project - NA0175 (Alternative 1)

Looking to the west, closeup of the breached dike area. The dike has failed by undercutting. Per the scheduled scope of work, this area will be fully excavated and backfilled. An additional 10 feet wide of material will be utilized to reinforce this dike. The upgradient clay sediment will be utilized as a source of borrow material. All slopes will be contoured to blend with the natural topography.

- A. The Dam repair will entail the excavation and backfilling of a breached portion of the dam. Borrow material will come from within the project boundaries. All backfill material utilized for the dam construction will be subject to soil testing to meet the compaction requirements at the Contractor's expense. Extreme care shall be taken to account for unforeseen heavy rains.

- F. Start with the backfilling of the keyway by 8-inch lifts with proper compaction and moisture. Continue the backfilling of the keyway and the dam repair until the dam meets the required specifications, front slope of 3h:1v, backslope of 1h:1v, dam top width of 10 feet wide.

- H. Widen the dam an extra 10 feet for the full length of 1,250 linear feet, side slope of 3h:1v and compact accordingly. This work is estimated at 6,500 bcyds.
